WEST NORWOOD CEMETERY A NEW BEGINNING

South Metropolitan (West Norwood) Cemetery Conservation Plan (Part 2)

Part of the Land Management Strategy

Conservation Plan: West Norwood Cemetery

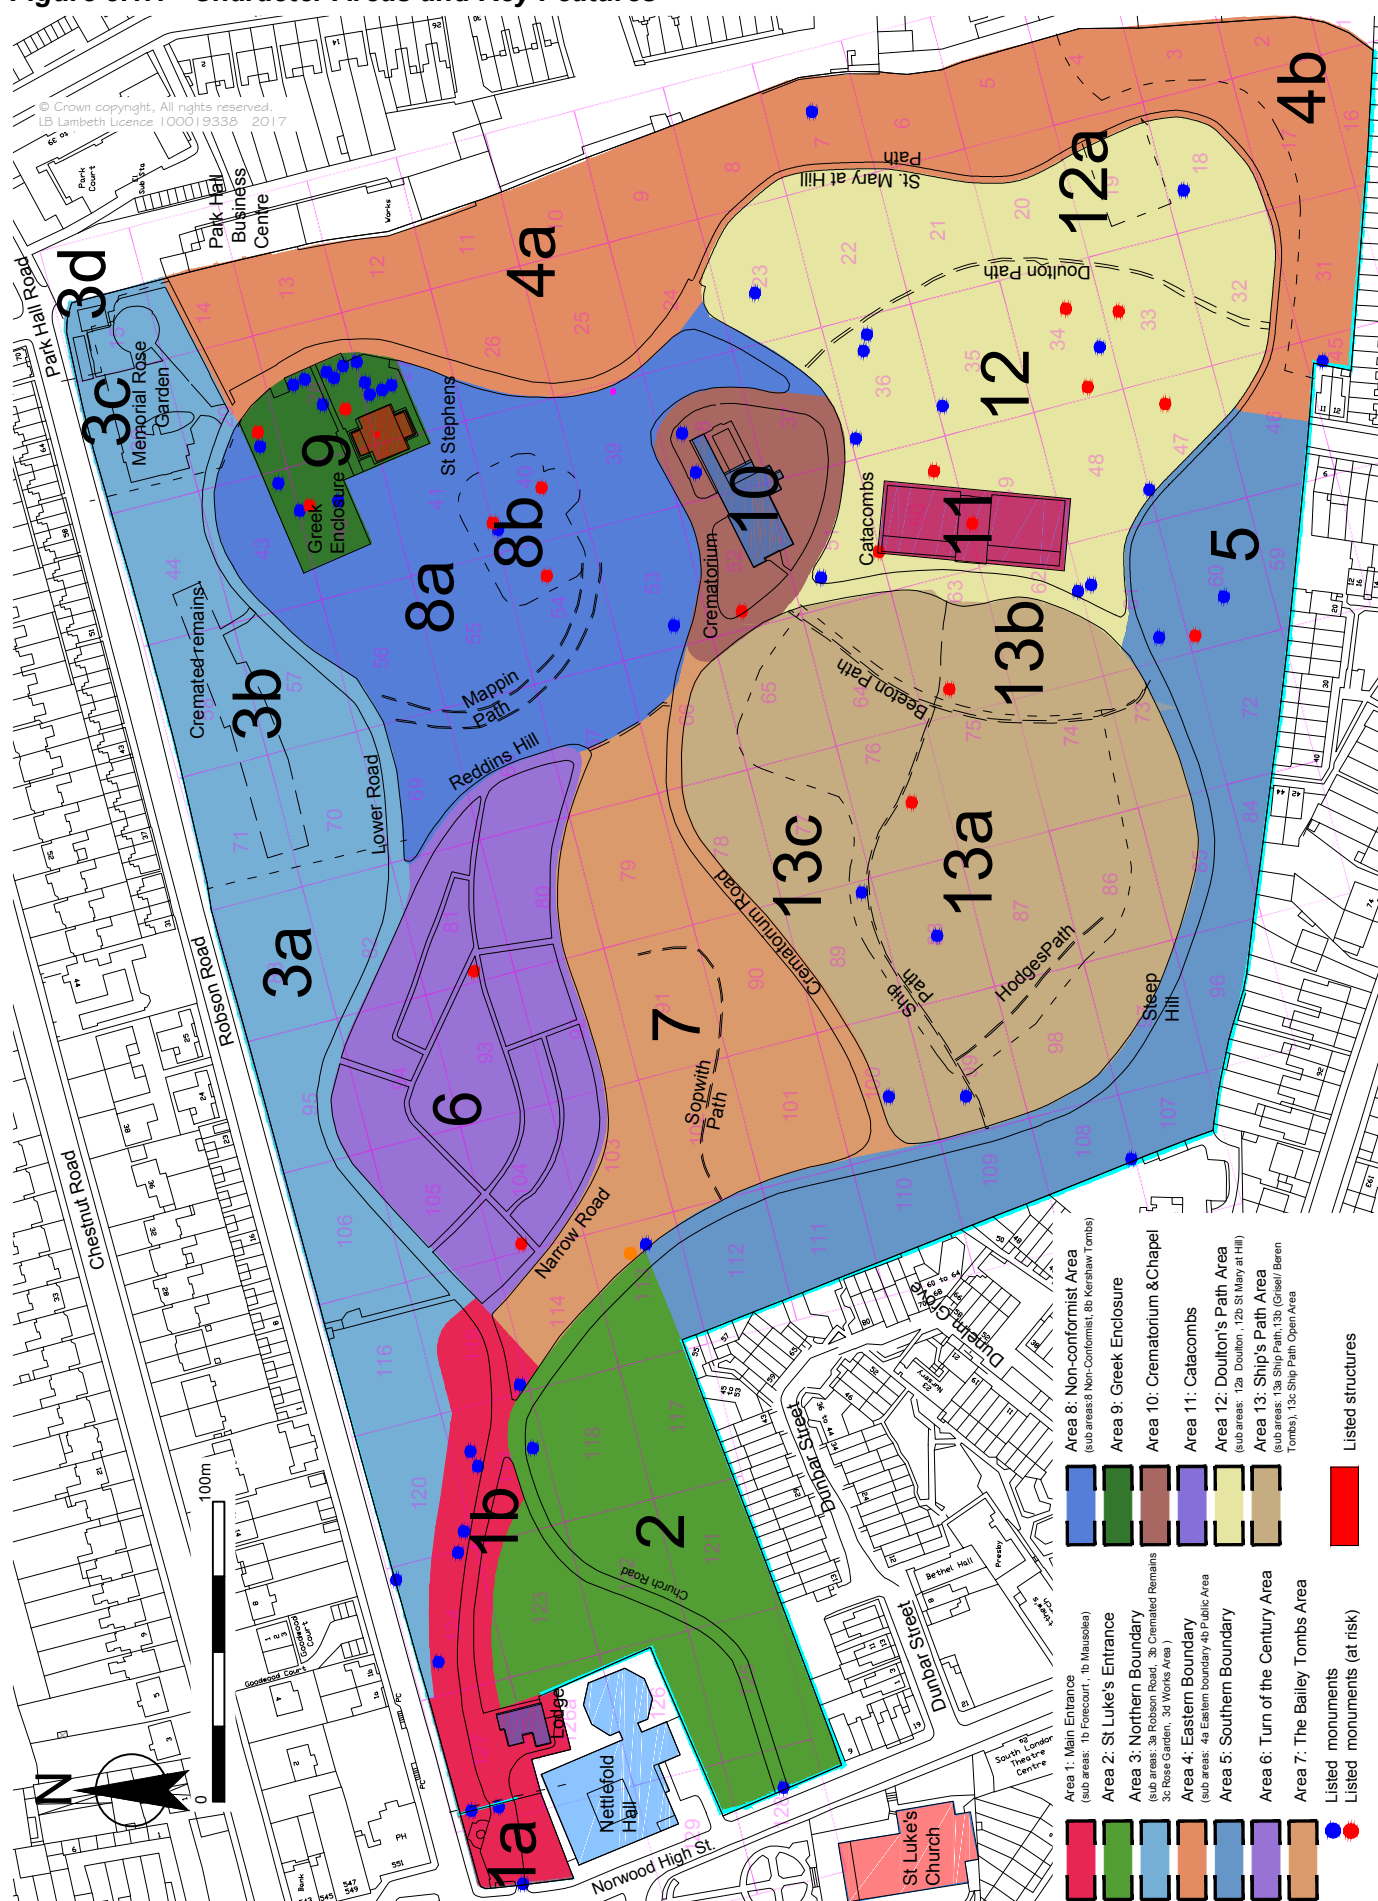
Figure 3.1.1 Character Areas and Key Features

- 3.2.1 The historic character of the Cemetery has been further appraised with reference to 13 principal character areas. These areas are shown on Figure 3.1.1, albeit it should be recognised that the areas are not homogenous and have indistinct boundaries. Some Character areas are further sub divided. Character Areas are fully described below.

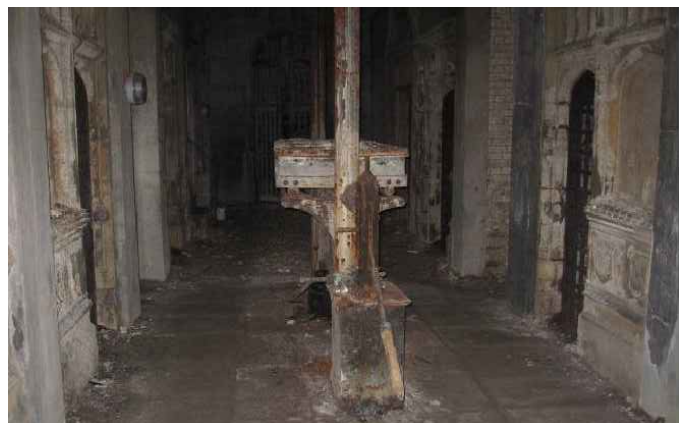
Catacombs interior with coffin lift

- 3.2.52 The siting of the Chapel over the Catacombs with lift arrangement was innovative, second only after Kensall Green. The catcombs remain still containing most of the original interments (including the remains of the Cemetery's designer, Sir William Tite) as surviving evidence to this arrangement. The catafalque lift (along with a slightly later model by the same manufacturer that replaced the original at Kensall Green) is one of only two surviving examples of this early Victorian innovation.

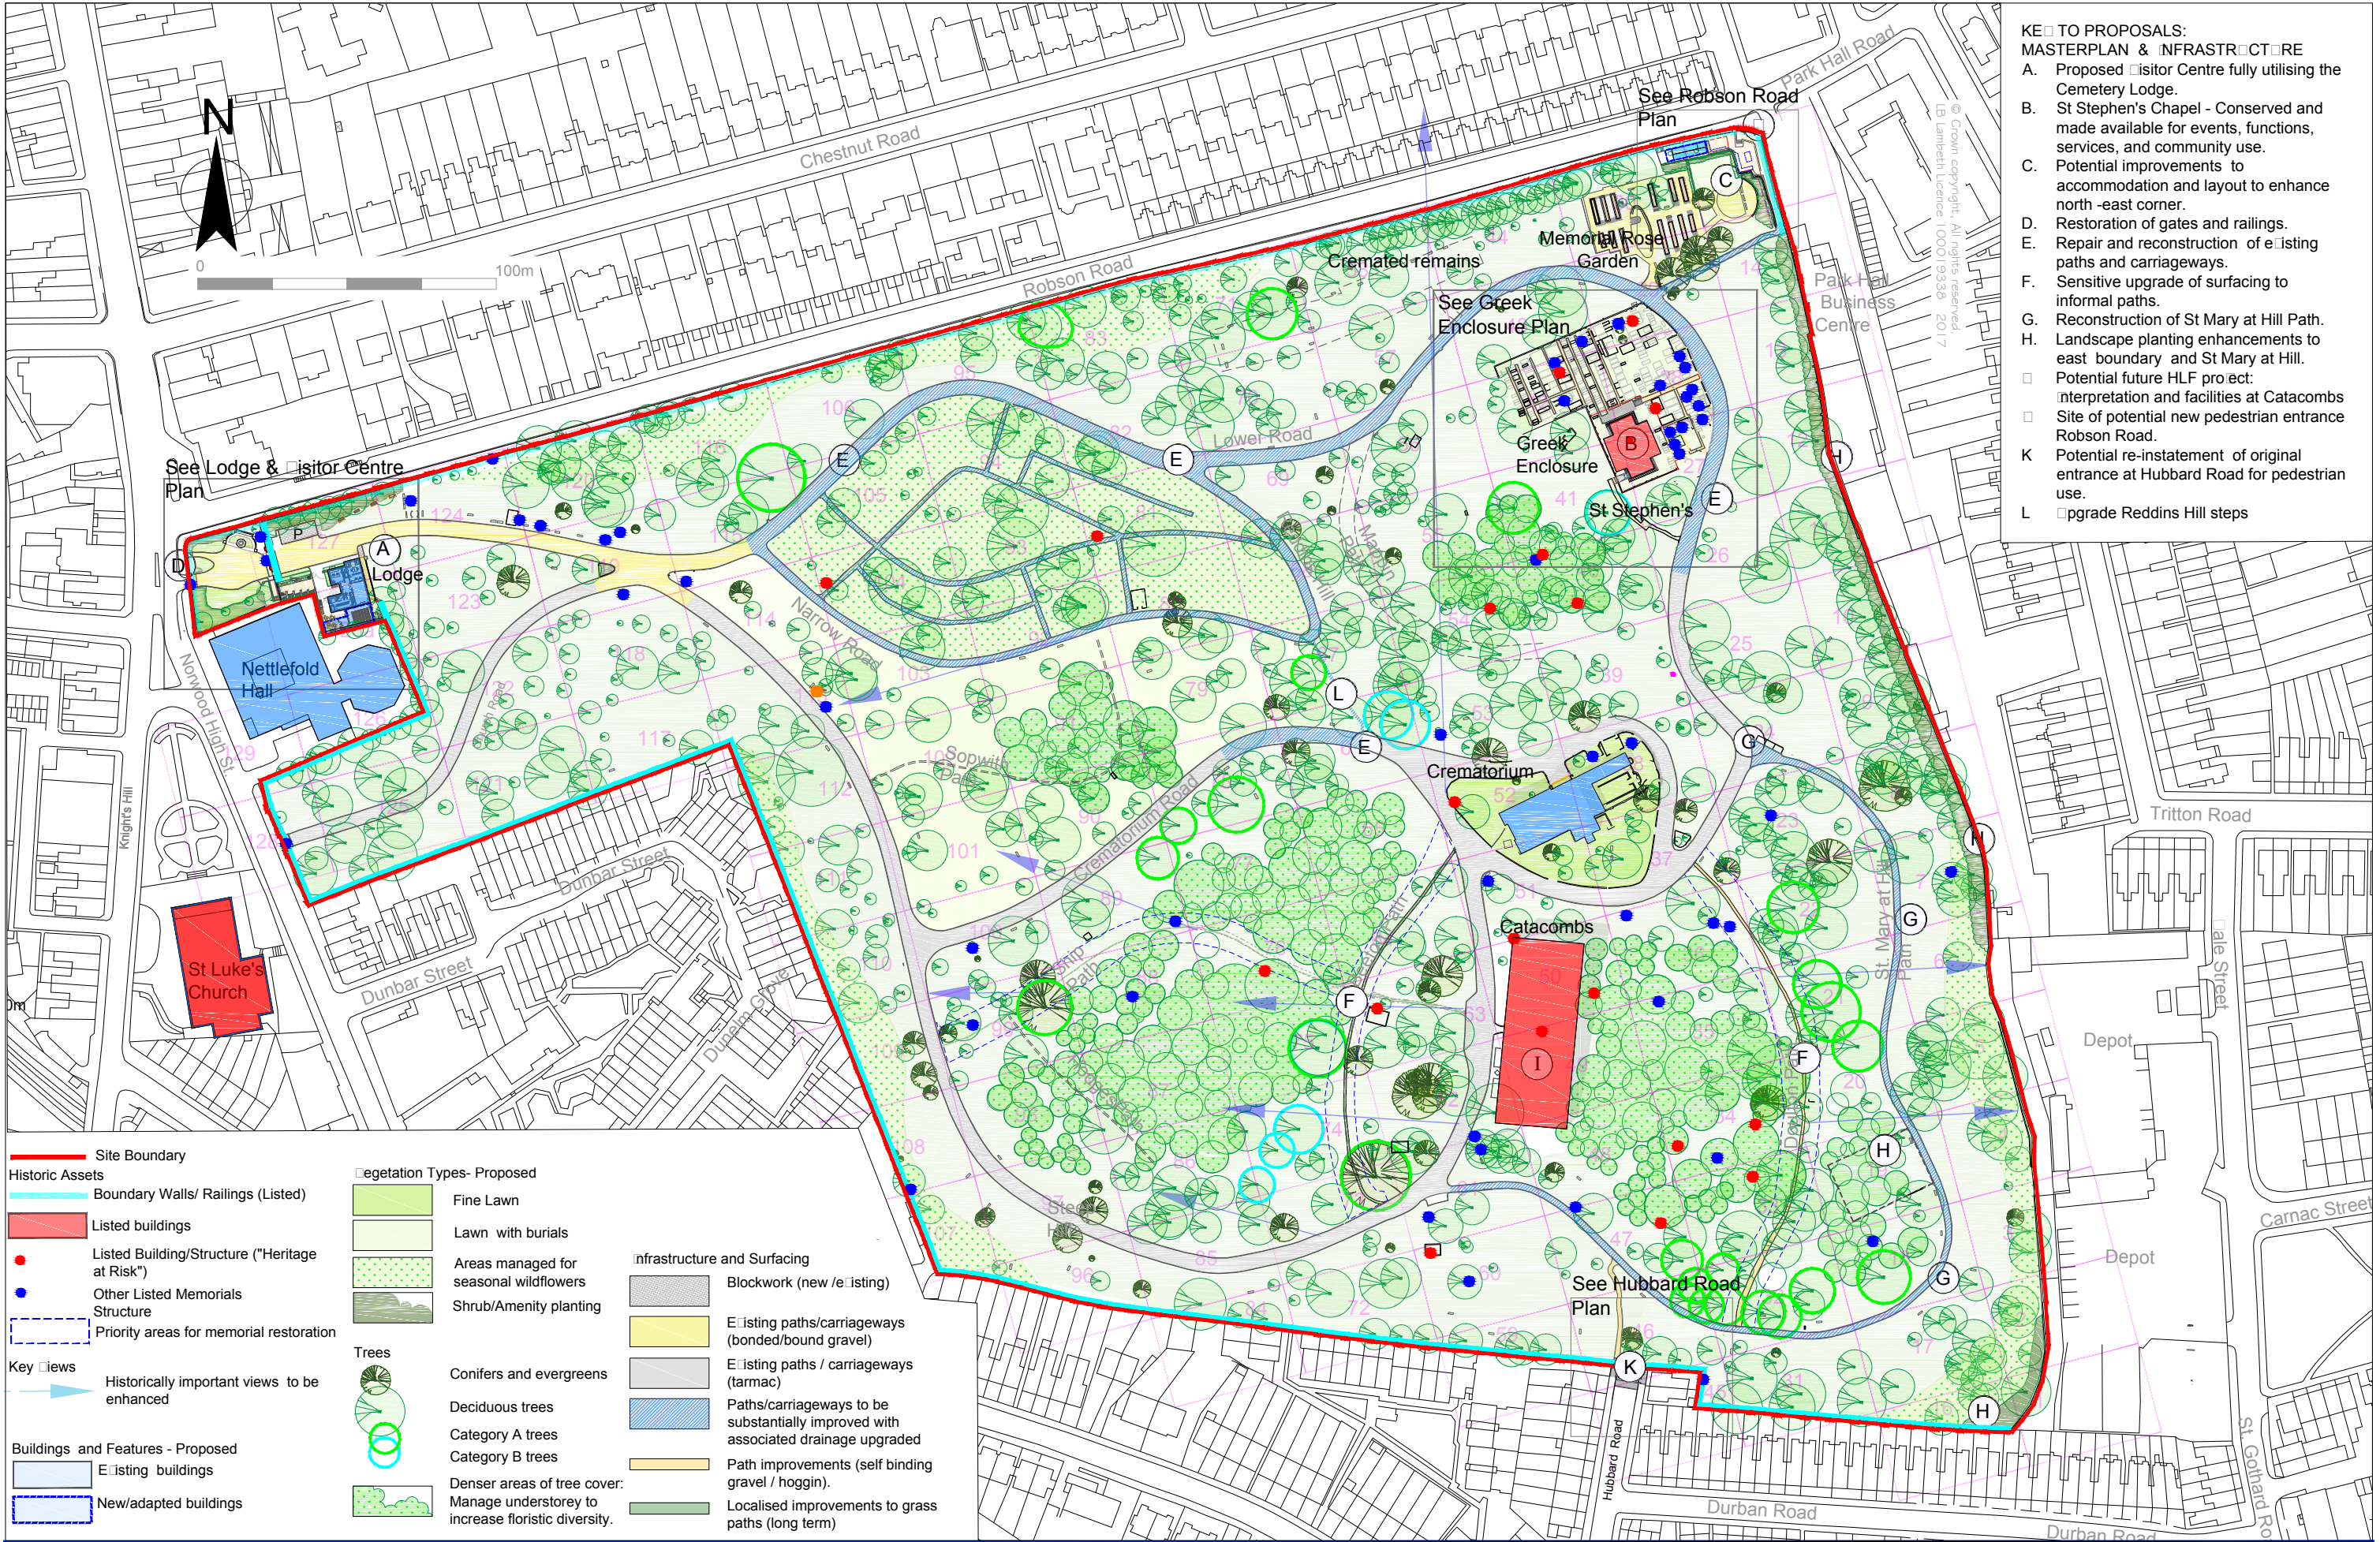
- KEY TO PROPOSALS:
MASTERPLAN & INFRASTRUCTURE
- A. Proposed Visitor Centre fully utilising the Cemetery Lodge.
 - B. St Stephen's Chapel - Conserved and made available for events, functions, services, and community use.
 - C. Potential improvements to accommodation and layout to enhance north-east corner.
 - D. Restoration of gates and railings.
 - E. Repair and reconstruction of existing paths and carriageways.
 - F. Sensitive upgrade of surfacing to informal paths.
 - G. Reconstruction of St Mary at Hill Path.
 - H. Landscape planting enhancements to east boundary and St Mary at Hill.
 - I. Potential future HLF project: interpretation and facilities at Catacombs
 - J. Site of potential new pedestrian entrance Robson Road.
 - K. Potential re-instatement of original entrance at Hubbard Road for pedestrian use.
 - L. Upgrade Reddins Hill steps

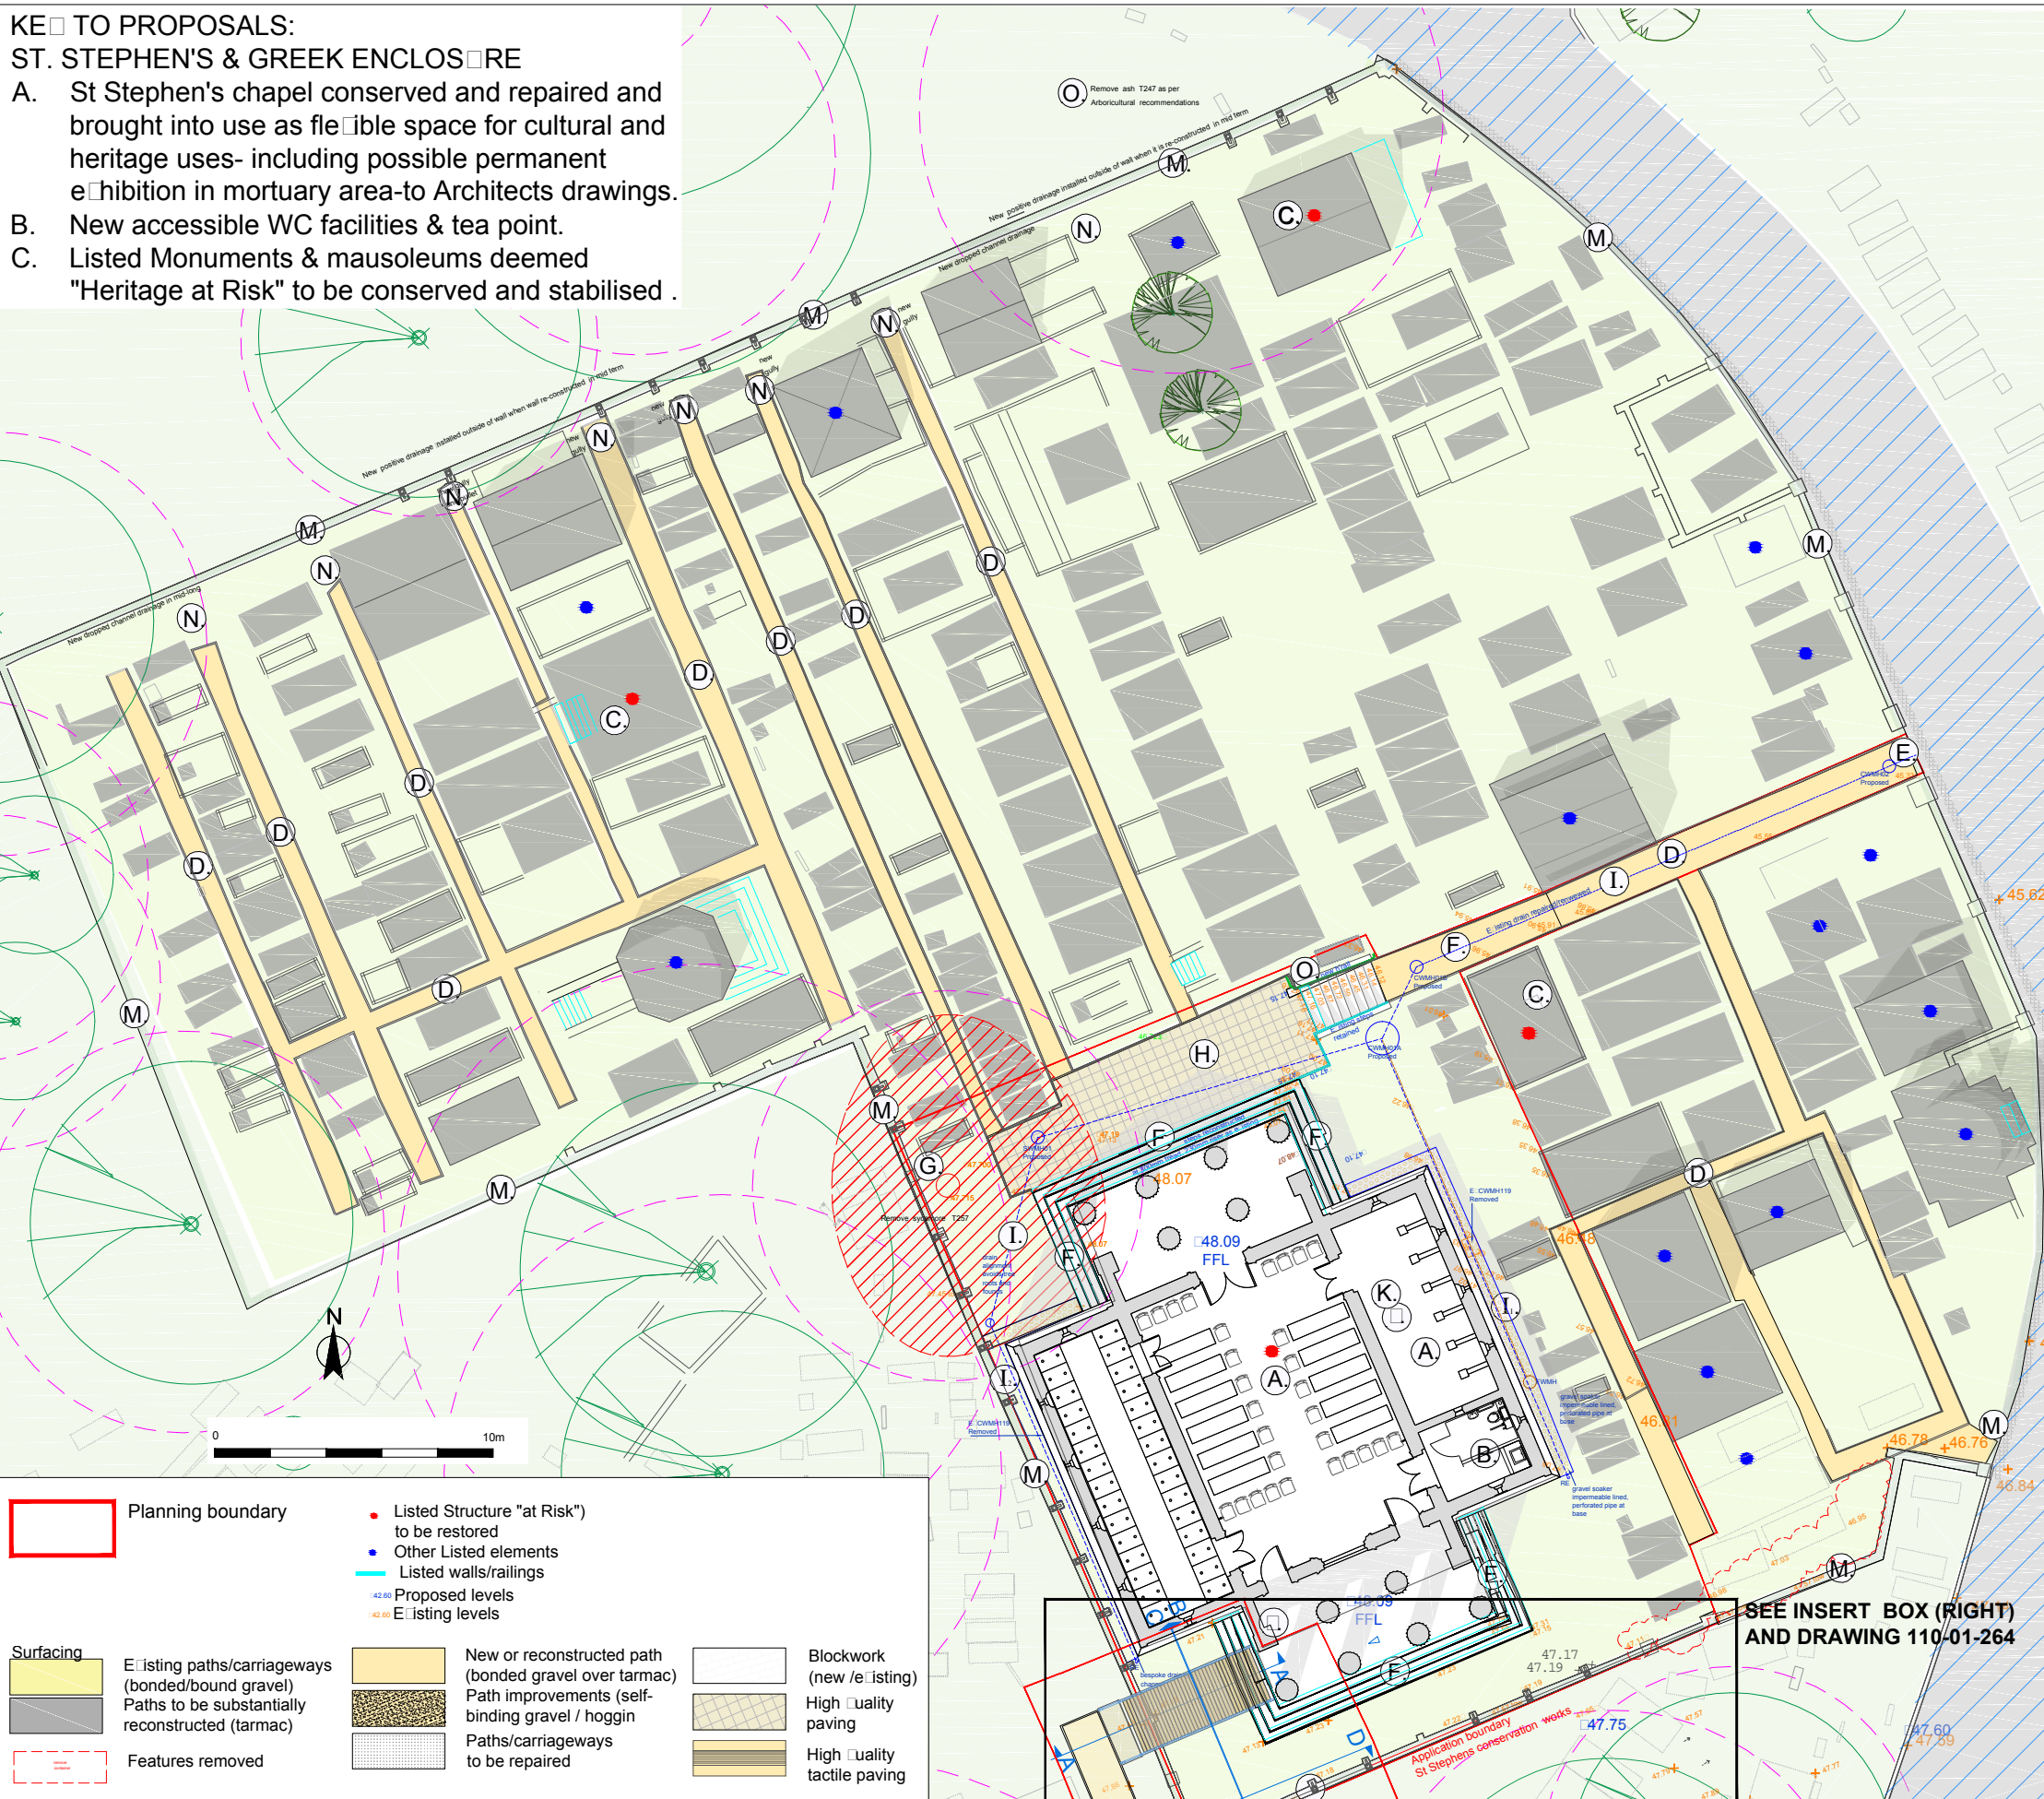
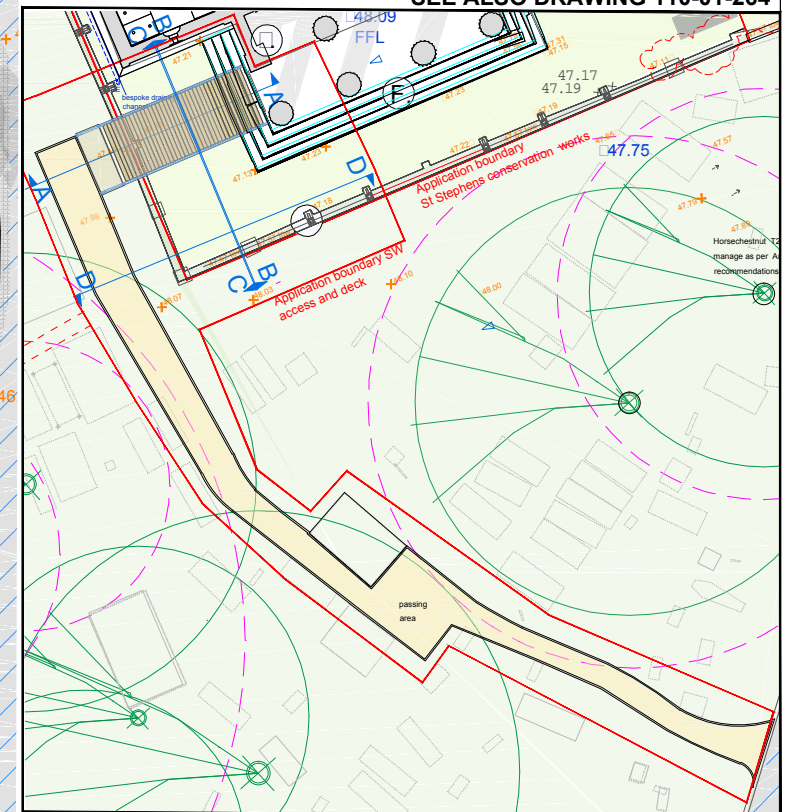
drawing title: Greek Enclosure Externals

**SOUTH WEST ACCESS PATH
SEE ALSO DRAWING 110-01-264**

**SEE INSERT BOX (RIGHT)
AND DRAWING 110-01-264**
